World Bank / Lake Chad Basin Commission

**APPRAISAL OF THE SAFETY OF MAGA DAM,
CAMEROON**

March 2002

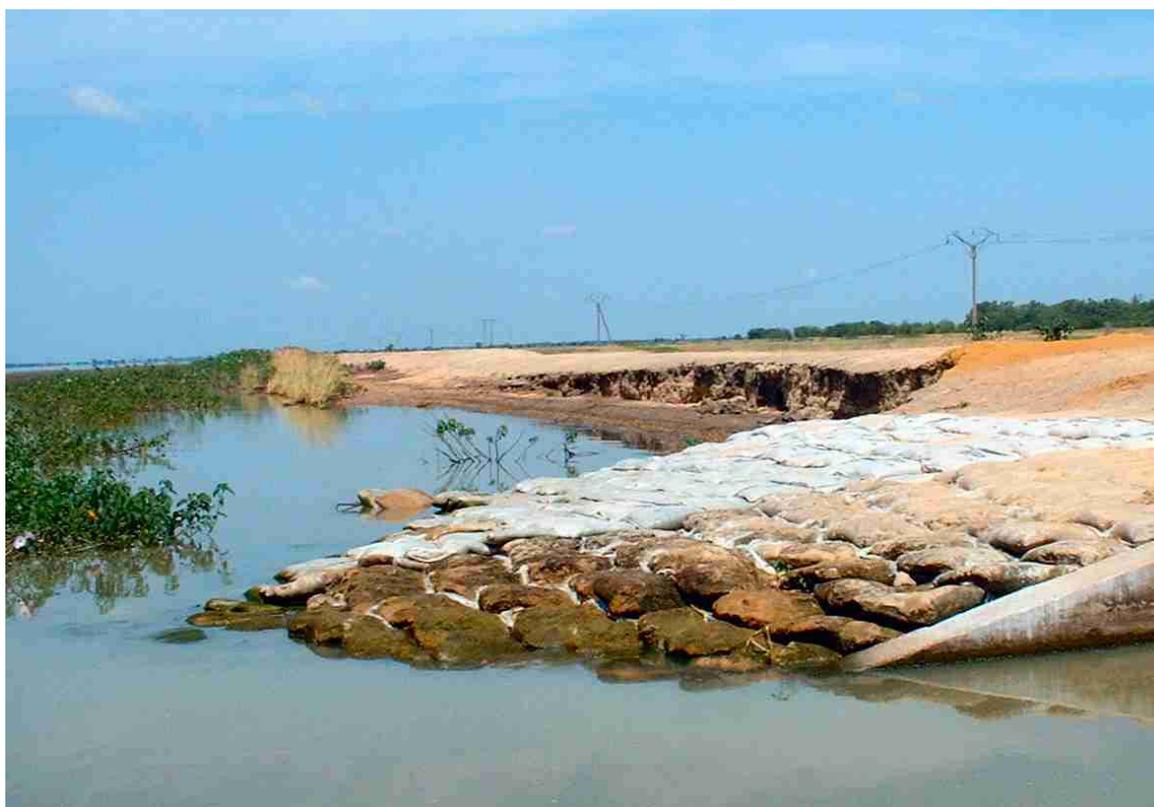
The upstream slope is not protected against wave attack except in the immediate vicinity of the outlet structures. As a result wave action, which is particularly severe in August and September when the reservoir is at its highest, has eroded material from the upper part of the upstream slope and deposited it at lower levels, as illustrated in Figure 3.1 and Photograph 1. This classic erosion process has already shortened the length of the seepage path at reservoir full conditions and will undoubtedly continue until the entire crest is eaten away, unless action is taken.

Photograph 1: erosion of upstream shoulder
(photo credit: Nicholas Hodgson)

If no action is taken wave erosion will continue until the crest of the embankment is eventually breached and the dam overtopped. To prevent this the damaged sections should be repaired with compacted fill and the entire slope protected with stones between elevations 312m and 313m.

Alternatively, or until this can be achieved, the maximum reservoir level should be restricted to 312.2m.

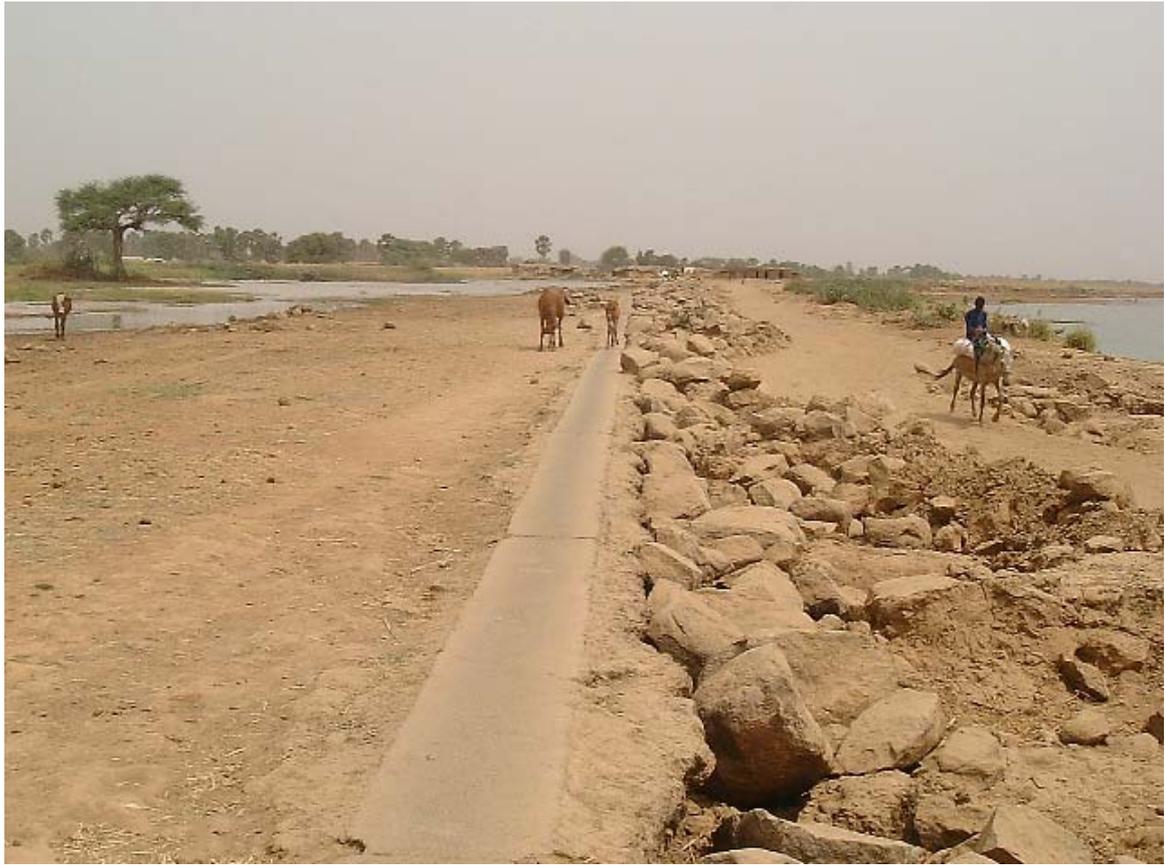
The spillway comprises a 750m long concrete cill set into the ground at 312.19m level, as shown in Photograph 2.

Photograph 2: Maga/Lagone spillway in the dry season

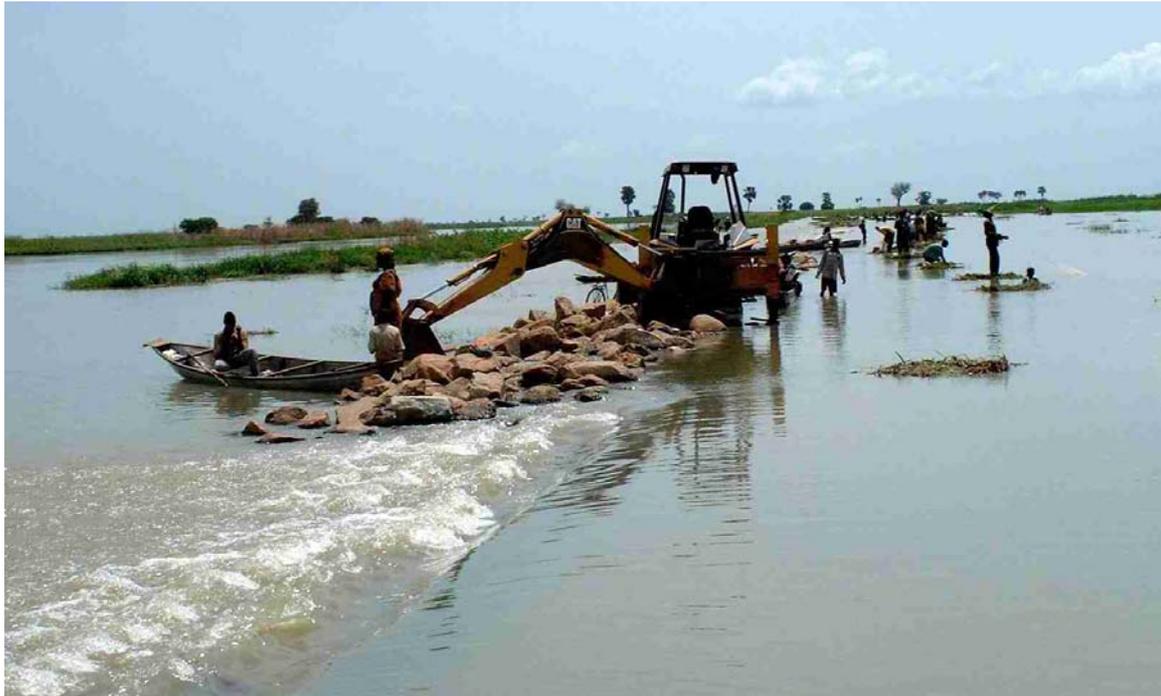
The local guardian reports that the cill is submerged every year, with water flowing from the river into the reservoir towards its upstream end and from the reservoir into the river at its downstream end. This phenomenon is explained by the disparity between the gradient of the water level in the river (about 1: 7500) and the horizontal water level in the reservoir. Photograph 3, taken on October 7th 2001 after the flood peak, shows water flowing out of the reservoir. During a major flood the river levels would be such that the flow would be into the reservoir along the entire length of the spillway.

Photograph 3: flow from the reservoir into the Logone at the northern end of the spillway. (photo credit Nicholas Hodgson)

Inflows can only be reduced by raising the crest level of the 750m long Maga/Longone spillway and reinforcing the flood protection dikes further upstream as necessary.
