GUINEA CURRENT LARGE MARINE ECOSYSTEM PROJECT

MISSION REPORT ON ELLAH LAKES PLC AQUACULTURE COMPLEX, OBRIKOM, RIVERS STATE, NIGERIA

September, 2005

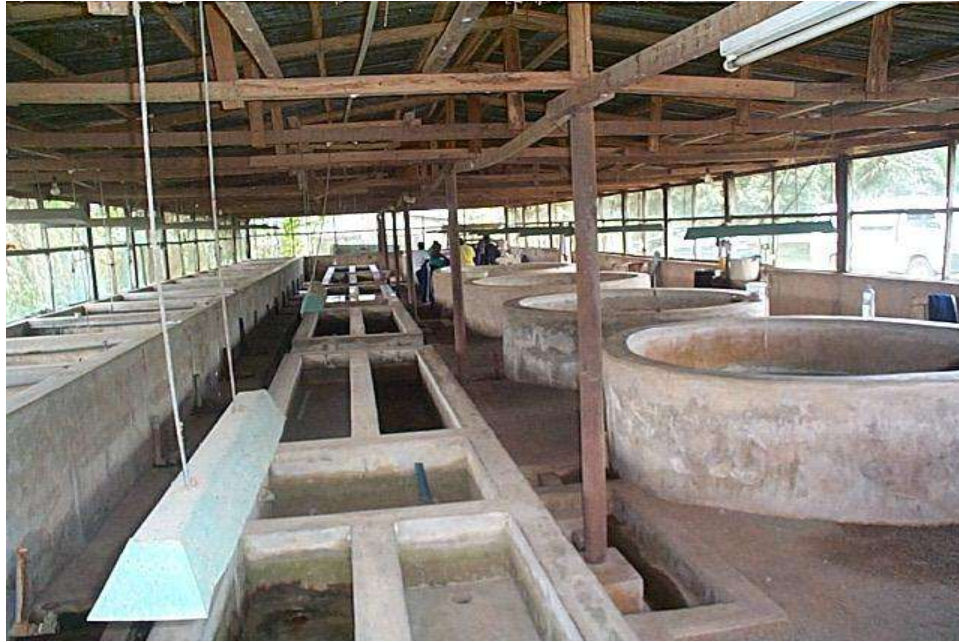
The hatchery system of Ellah Lake PLC comprise of well-engineered concrete-type units made up of 12 circular tanks, 13 square tanks, 2 rectangular tanks and 12 raceways (Plate 1). On a 5-point grading system ranging from excellent (5) to poor (1), the overall rating of the hatchery (structure and function) is pegged at 3 (good). Operating at full capacity, conservative estimates of fry production from the approximately 10 MT-capacity tank units is put at 3,660,000 fish fry per cycle of 8 weeks.

Plate 1. Lay-out of the Hatchery at ELP

As observed elsewhere, the engineering design and lay-out of the hatchery tanks and drainage systems cannot be faulted. However, lack of a wet chemistry laboratory to provide levels of the much needed water quality parameters in in-flow waters into the hatchery and in operational hatchery tanks, largely reduces every work done in the hatchery to a status of mere guess work, as far as water quality is concerned. It is acknowledged, though, that a pH meter and some hand gloves for hatchery operations have been recently acquired. While this is highly commendable, it must be emphasised that it is woefully inadequate for the running of the hatchery.

The general sanitary conditions of the hatchery, including the state of the floor, do not seem to lend much support to the efficient running of the facility. There is a need for an immediate remediation of that situation. Furthermore, too many ill-dressed staff make their ways to the hatchery too frequently. This action only promote high incidence of nosocomial diseases in the fish fry.

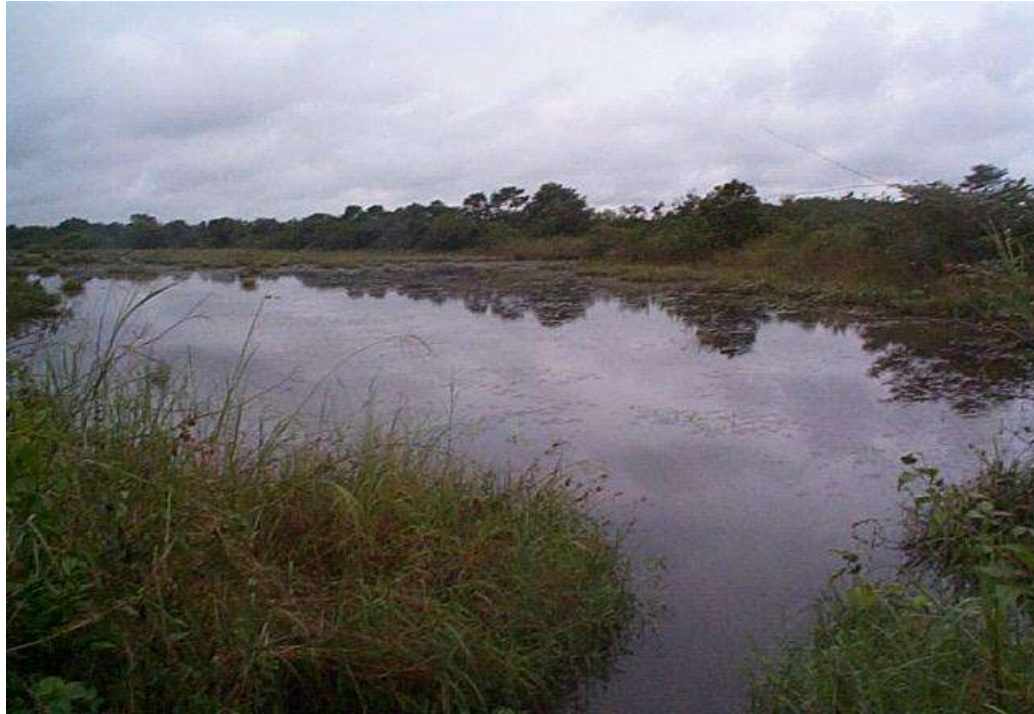
Available records indicate that there are a total of 91 grow-out earthen ponds and one reservoir pond in various operational stages in the complex. Pond sizes range from 0.2 Ha to 6.8Ha. About 22 of these ponds are in various stages of construction or disrepair. A further 61 ponds have not been fitted with drainage weirs while the remaining 8 ponds, covering an estimated area of 11.28 Ha, are in complete operational states. A typical grow-out pond at ELP is presented as Plate 2 below.

Plate 2. A typical grow-out pond at ELP

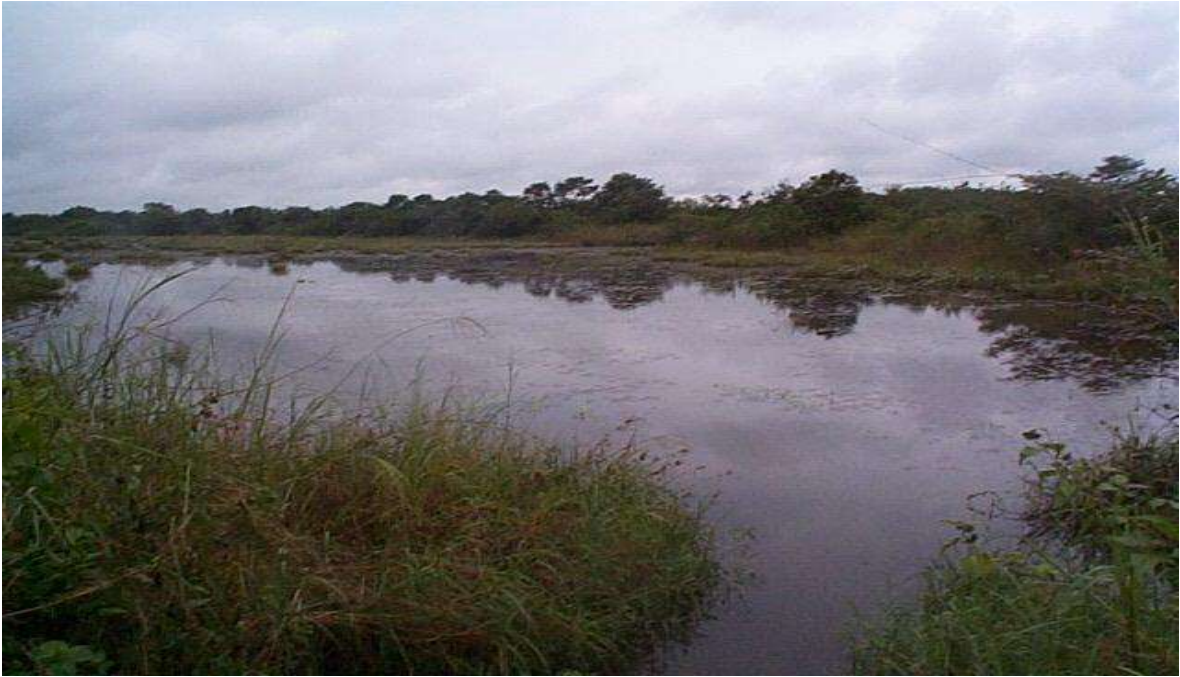
1 A typical Functional Grow-out Pond at ELP

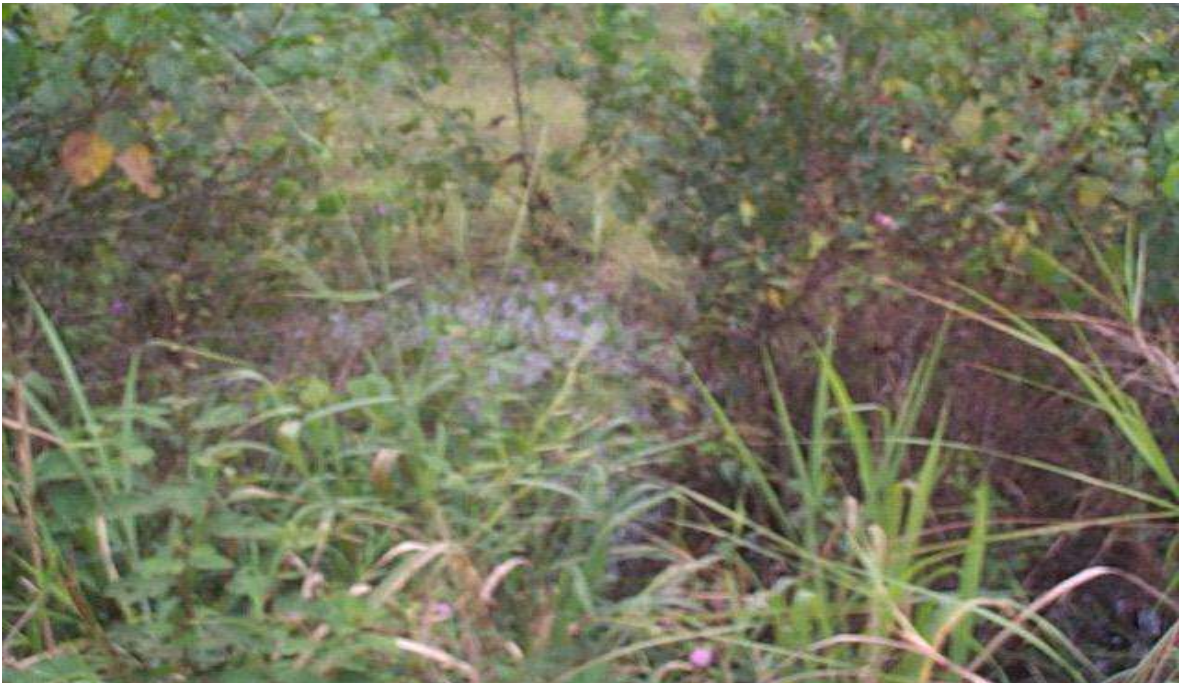
A substantial number of the grow-out ponds are not equipped with drainage canals. An equally large numbers of ponds are currently overgrown with weeds and shrubs while the operating ponds are badly infested with all kinds of wild fish species, possibly resulting from the periodic flooding of the facility. Water quality parameters and bottom conditions also remain largely unknown. The physical and chemical problems aside, poaching of both human and animal origin also do militate strongly against the projected production levels of the ponds.

2 A Typical Non-functional Pond (overgrown with weed) at ELP

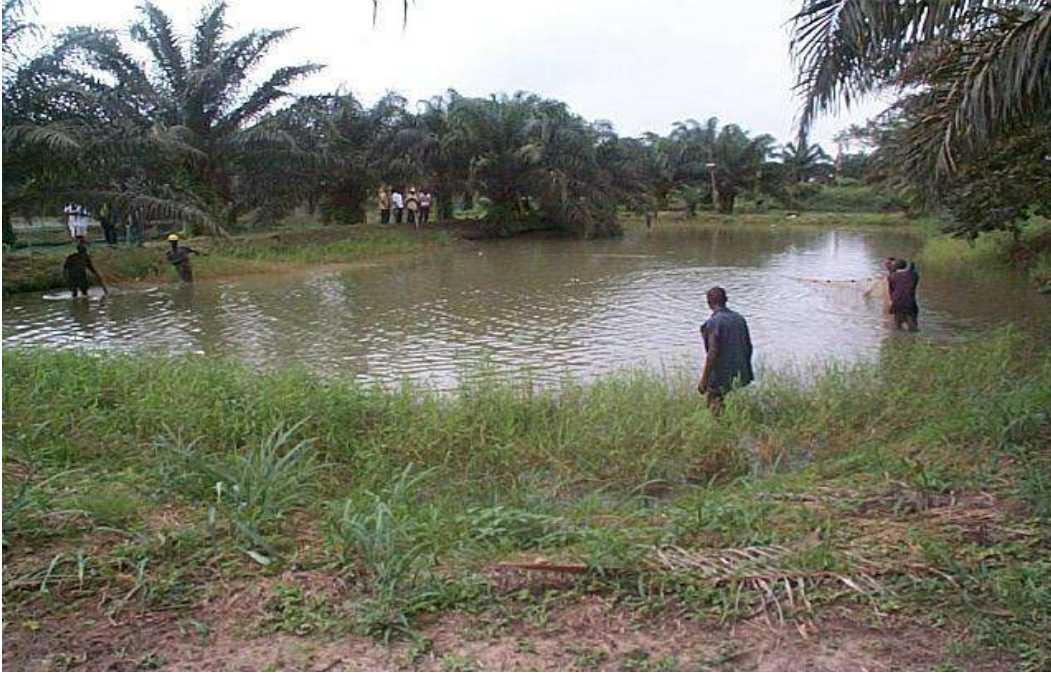
3 Harvesting Fish from a Grow-out Pond

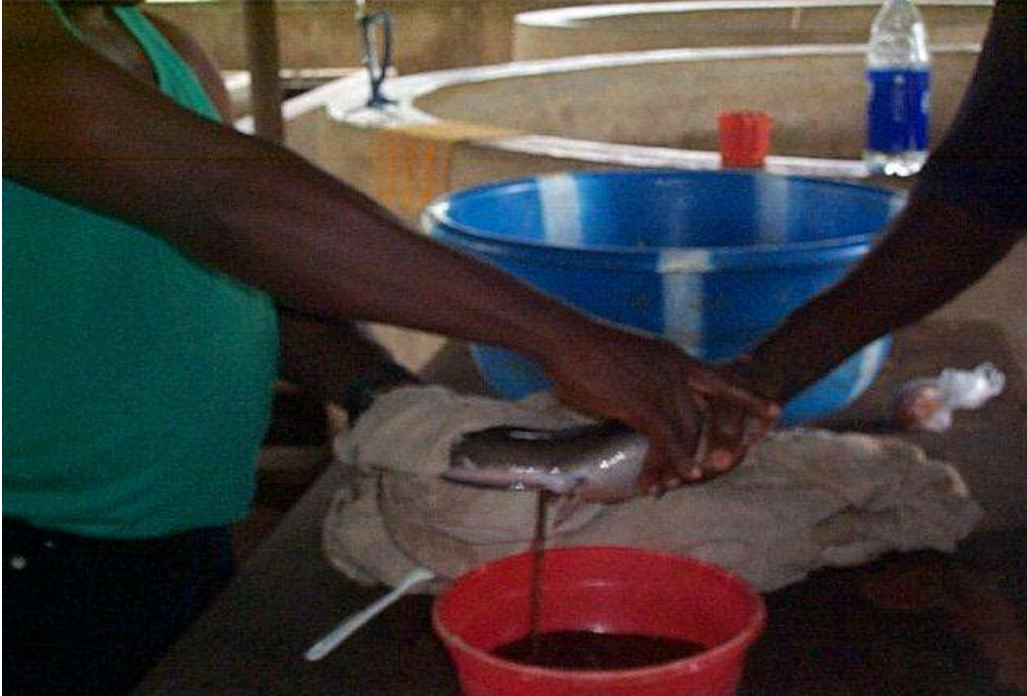
5 Stripping a Catfish for Eggs after 18 hours Inducement

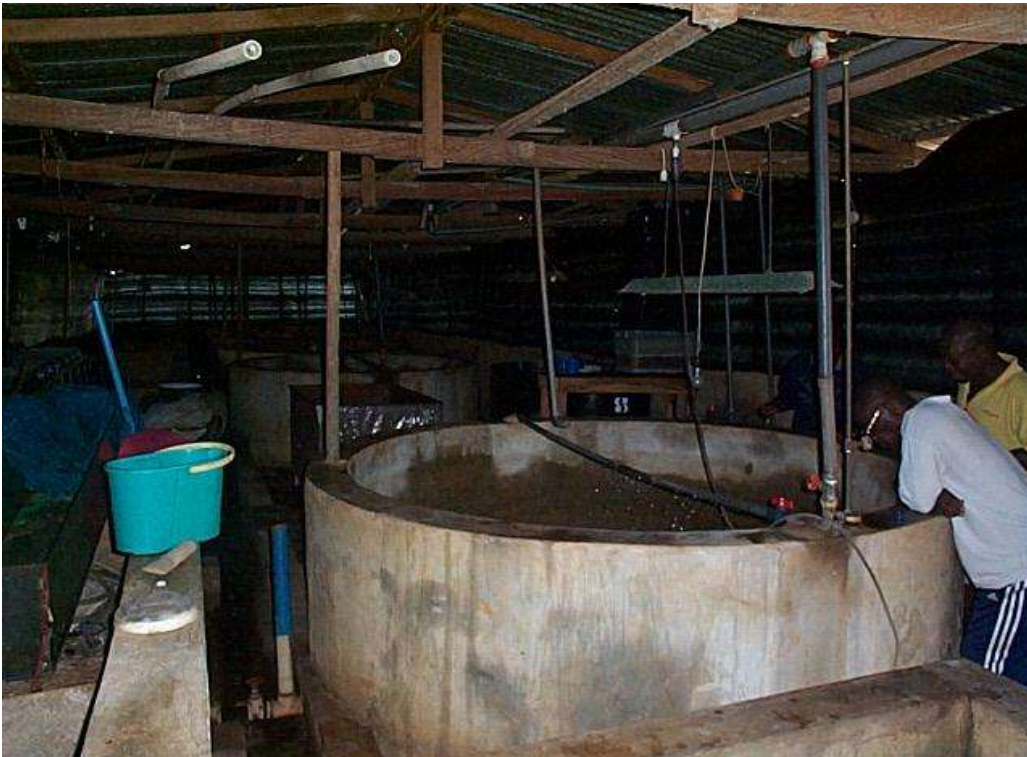
6 GCLME Consultants Inspecting a Hatchery Tank in the Dark Room
