# Workshop Report

**UNDP GEF Project on Lake Tanganyika: DRC Erosion Risk Mapping and Site Selection Workshops, Uvira, Democratic Republic of The Congo, December 2010**

**World Agroforestry Centre (ICRAF)**

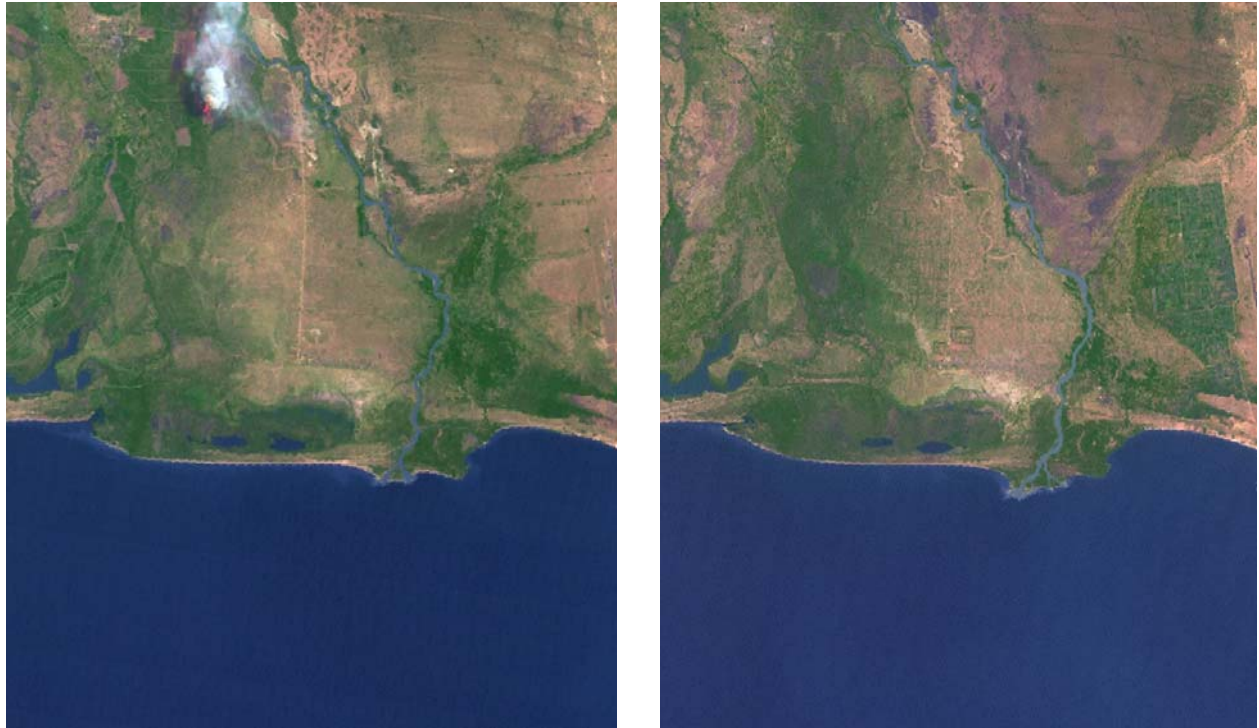
*Figure 4. Growth of the Rusizi River Delta on the northern shores of Lake Tanganyika between 1986 (left) and 2000 (right).*

The growth of the Rusizi Delta in Lake Tanganyika as recorded in high resolution satellite imagery (Landsat) indicating that the sediment load on the lake is high from the Rusizi River (Figure 4).

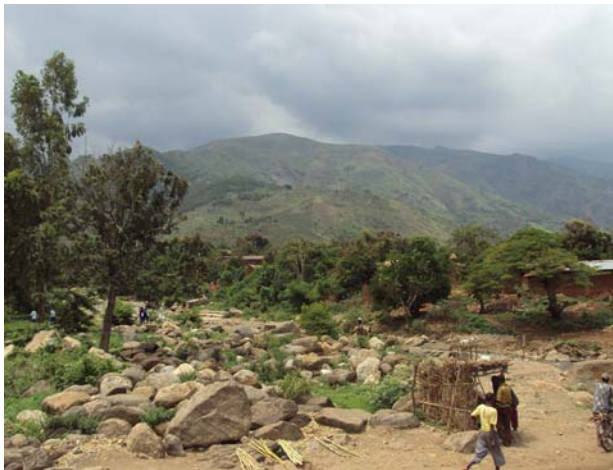
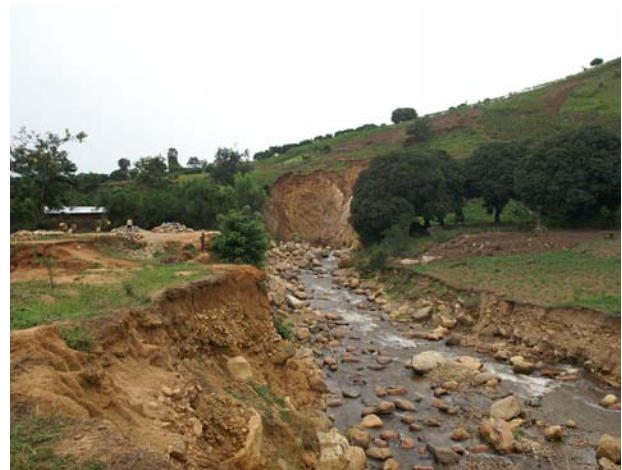
*Figure 8. Sub-catchment and villages chosen for interventions ; a) Kigongo River at Kigongo village (photo by Jules Bayala), and b) Kalimabenge River at Kijaga village.*

Based on the above criteria, the meeting concluded choosing three project sites: the sub-catchments of Kigongo, Kalimabenge-Mugudja and Mulongwe rivers (table 1, figures 8 & 9). The choice of these sites took into consideration their contribution to the lake sedimentation and areas that need intervention.

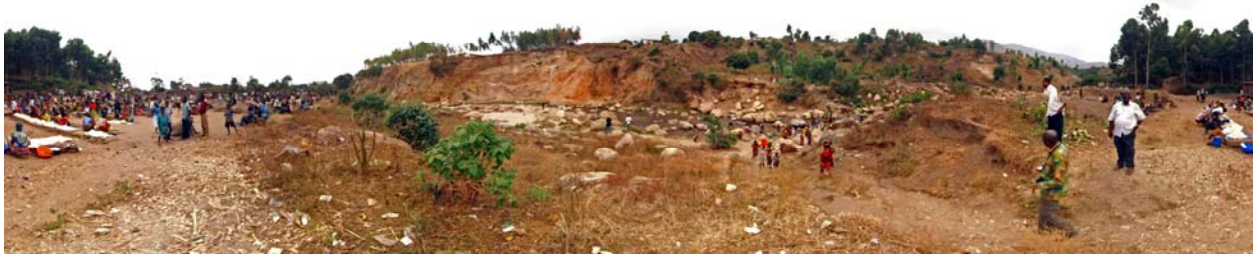
*Figure 9. Mulongwe River at the market place just upstream of Uvira town. 360 degree panorama.*
