World Bank / Lake Chad Basin Commission

**APPRAISAL OF THE SAFETY OF MAGA DAM,
CAMEROON**

March 2002

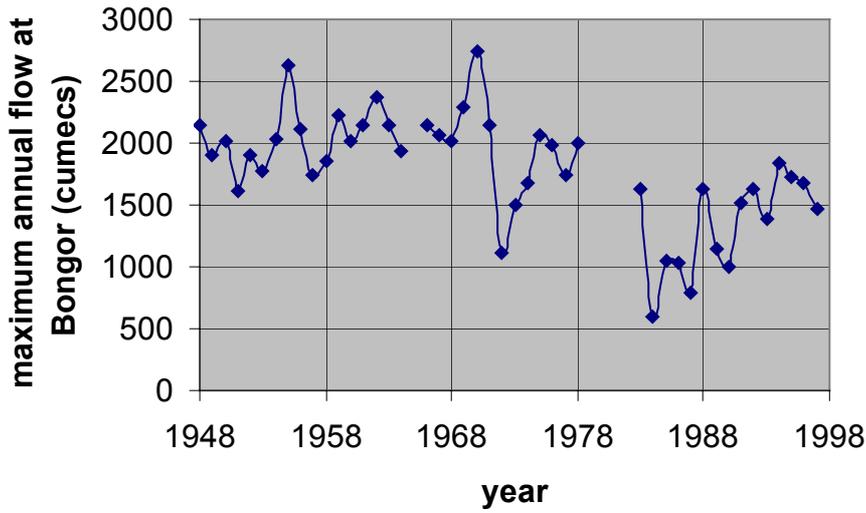
Figure 3.4: annual maximum flows at Bongor

Daily flows of the Logone river have been measured at Bongor, 75km upstream of Pouss, since 1948. A plot of the annual maximum flows is presented in Figure 2.4. This plot shows the marked reduction in flood peaks since the 1970's.

In the absence of any flood studies it is difficult to assess the threat posed by overtopping. The maximum annual flow data presented in Figure 2.4 shows that the maximum flood that has occurred in the Logone since the dam has been constructed was in 1994 when the peak flow at Bongor was 1840m³/s. Unfortunately the records of river level at Pouss were not available for inspection so it is not possible to know what the peak flow or river level were at Pouss at that time. It is clear however that even the modest flood peaks that have occurred in the lifetime of the dam have caused the reservoir level to rise to at least 312.5m, leaving a freeboard of less than 1.75m. The 1994 peak flow was only 67% of the maximum recorded peak flow (2740m³/s in 1970) which itself should not be regarded as a particularly severe event. It would seem to be probable that the return period of a flood in the Logone that would result in the embankment being overtopped may be relatively low, possibly as low as 1 in 100 years.
